# HOME INSPECTION REPORT

Mr. & Mrs. Happy Buyer

1234 Pleasant Lane  
Jupiter, FL

**Date & time:** February 6, 2018

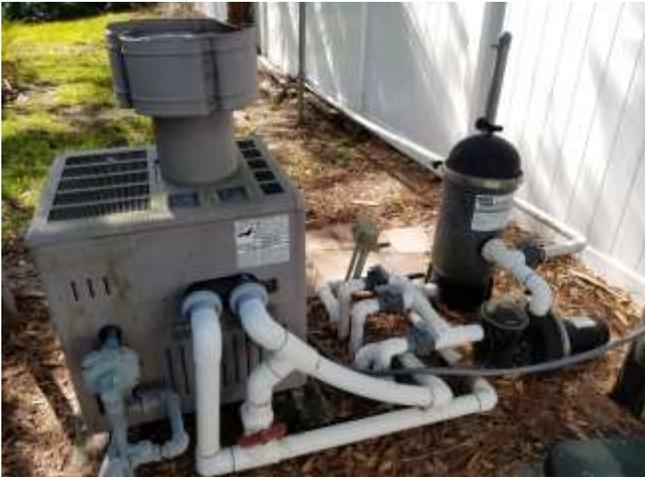
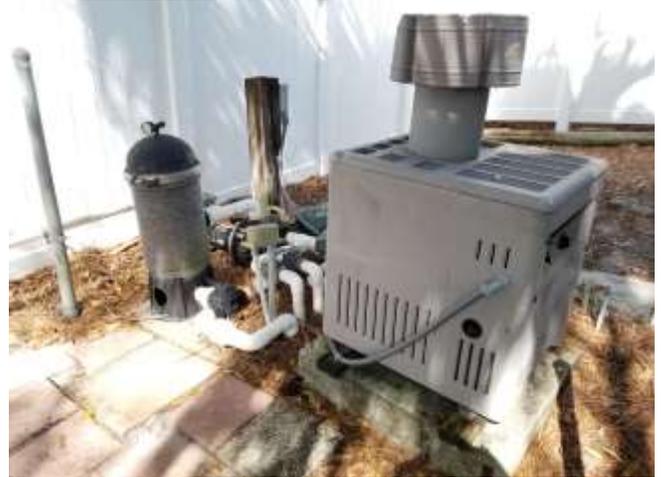
The pools finish was good, the light was lit and a water fall function was noted to work. The pool motor and filter appeared older and possibly original but no defect was noted.  
**The pools heater did not start.**

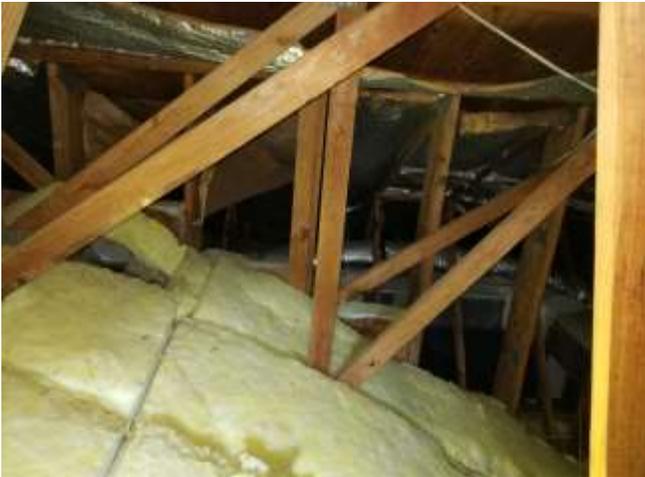
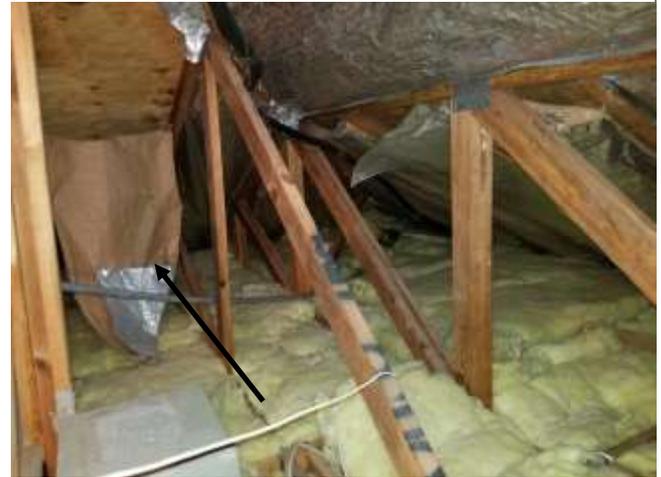
Some of the foil insulation stapled to the underside of the roof is hanging loose. This is typical with age.

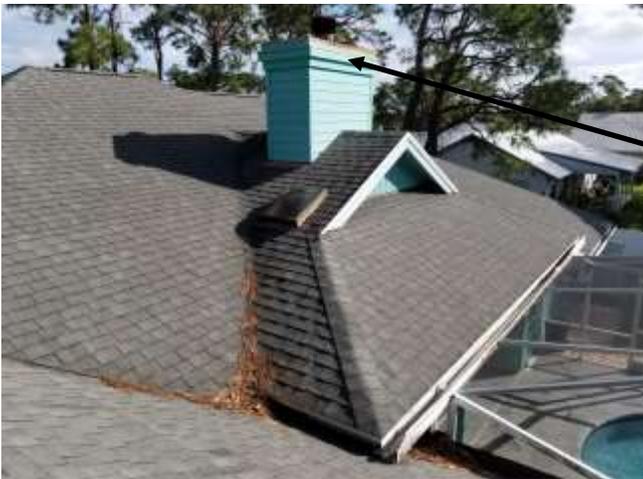
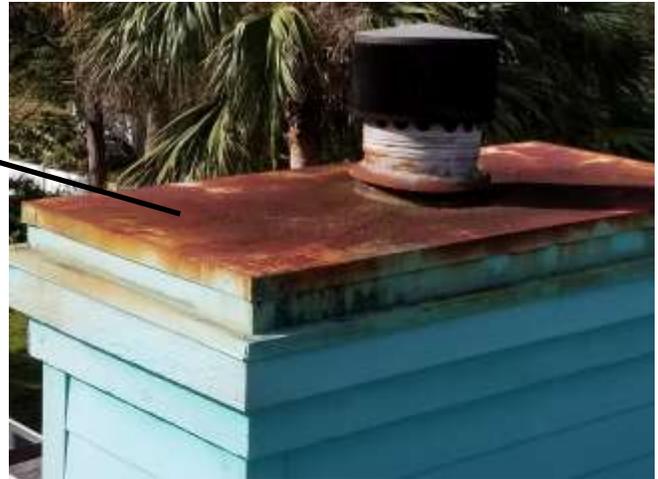
**The chimney cap was sound and does not leak is but is rusting on its top. Properly cleaning, treating and painting will extend it's serviceable life.**

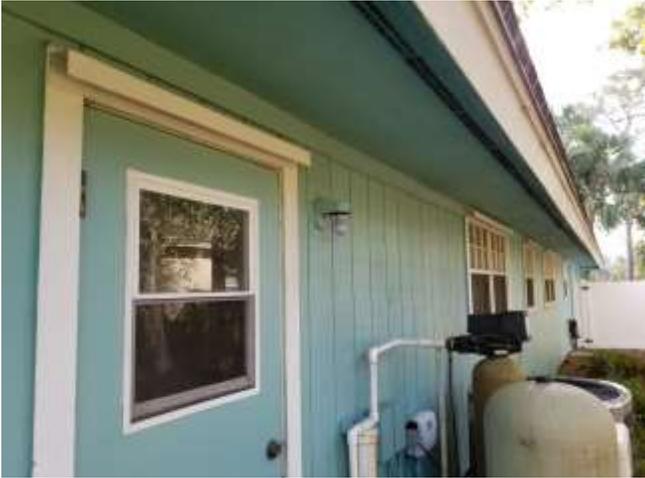
The coach light on the garage rear door was missing it's globe and did not light.

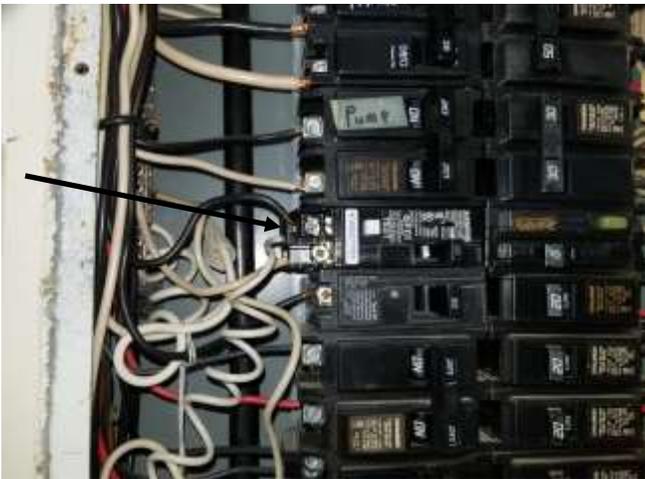
There is a GFCI type breaker in the panel box which appears replaced and serves the east side bath and exterior outlets.

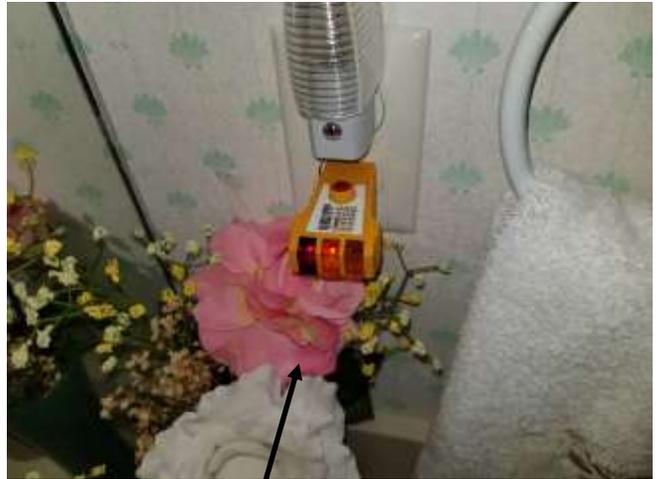
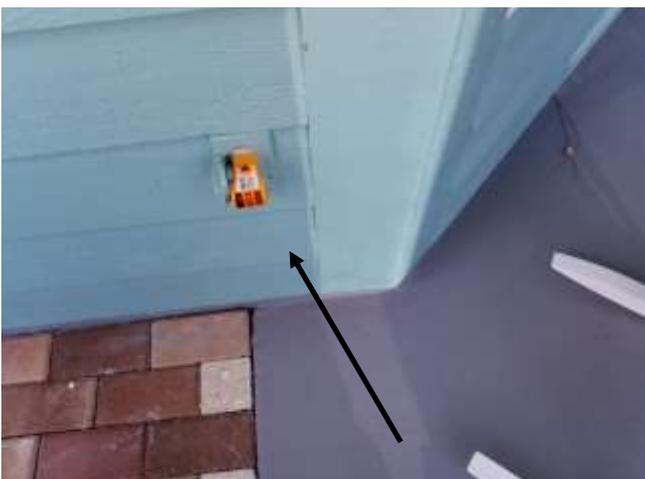
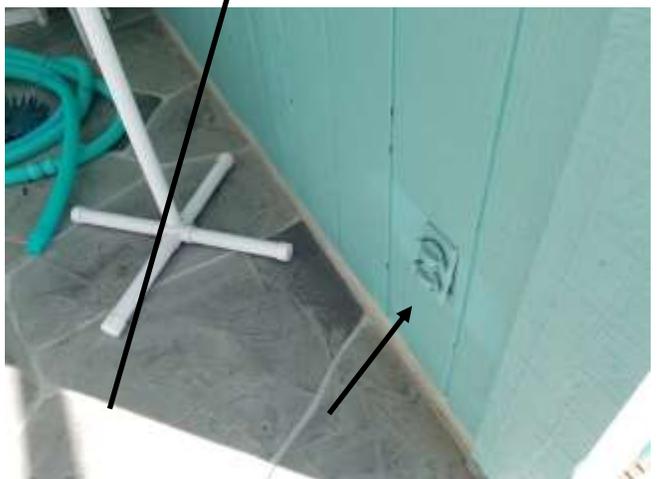
The exterior and garage outlets are not GFCI protected and should be since 1975. \*There is a GFCI type outlet on the patio by the family room door which did not trip off when tested.  
\*The outlets on the exterior front and east side have their black and white wires connected in reverse. The outlet on the patios master bedroom wall is loosely secured to the electric box.

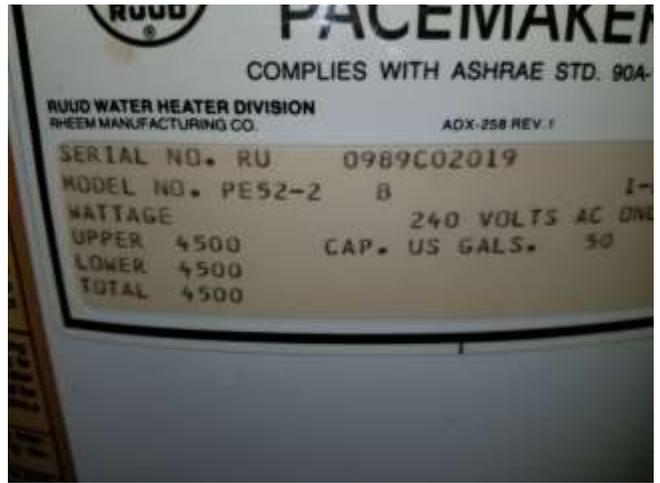
**Water Heater**

**\*The pressure relief valve on the water heater did not release when tested. It is not uncommon for valves which are more than a few years old to stick due to our mineral rich water.**

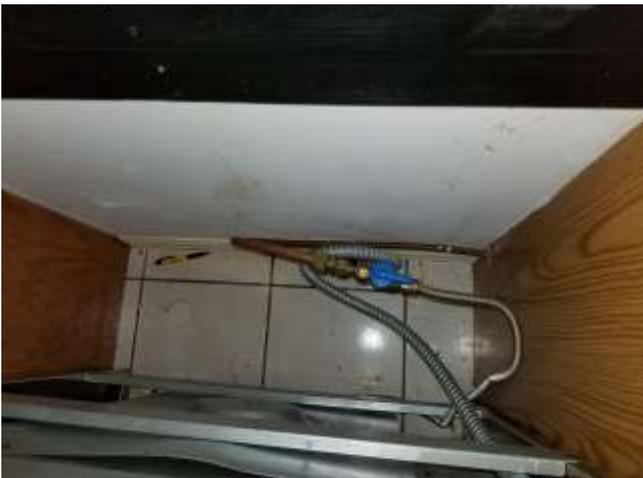
**View behind oven**  
No anti-tip foot was noted installed under the rear leg of the stove. This bracket prevents newer and lighter stoves from tipping over if both trays are pulled out

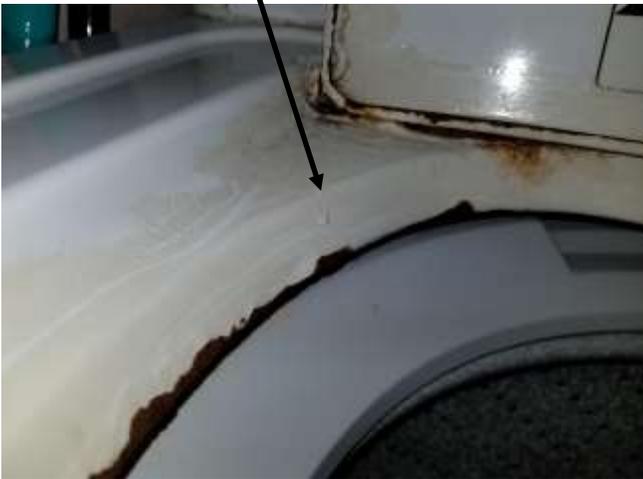
**On the cloths washer some rust and painting was noted on the lid and around the washer baskets rim.**

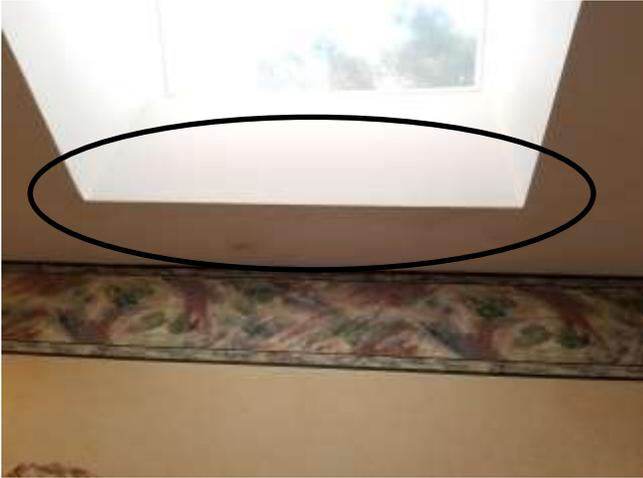
**In the east hall bath some staining was noted on the ceiling at the base of the skylight. No moisture or damage was observed and it is thought to be from the old skylight.**

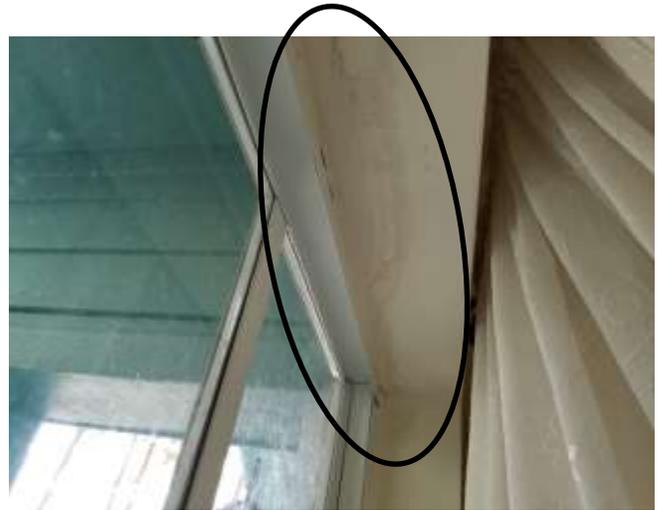
**In the front window to the west of the entry door some staining was noted to the top of the frame. No moisture or damage was noted.**

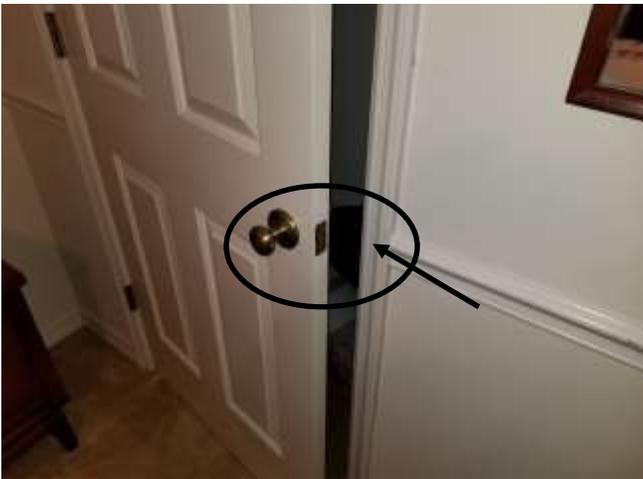
**\*In both east bedrooms one of the closet doors lock knobs latch did not engage the strike plate on the jamb.**

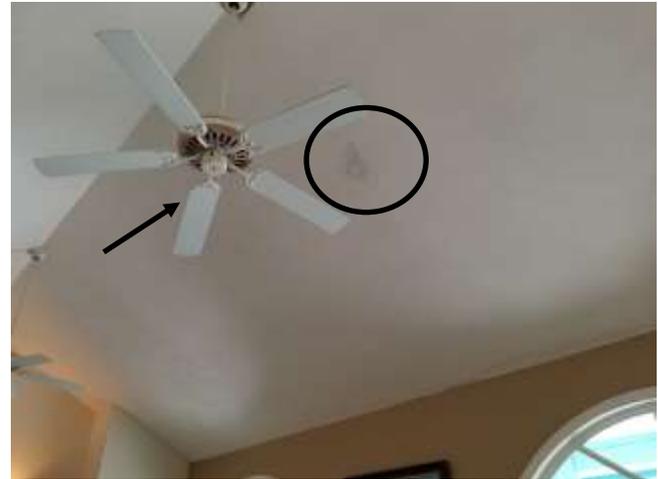
**A repair was noted in the living room ceiling. The owner stated a projection TV was hung from that location and it needs to be painted.**
