# HOME INSPECTION REPORT

Mr. & Mrs. Happy Buyer

1234 Pleasant Lane  
Jupiter, FL

**Date & time:** February 6, 2018

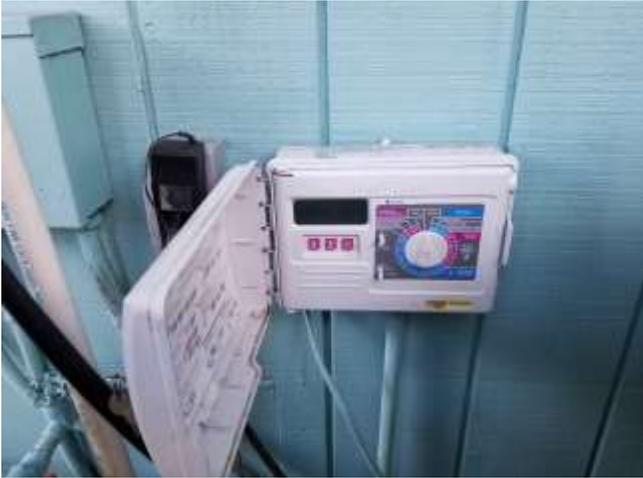
**Programmable Rain Bird brand clock, served by a well located n the west side of the house.**

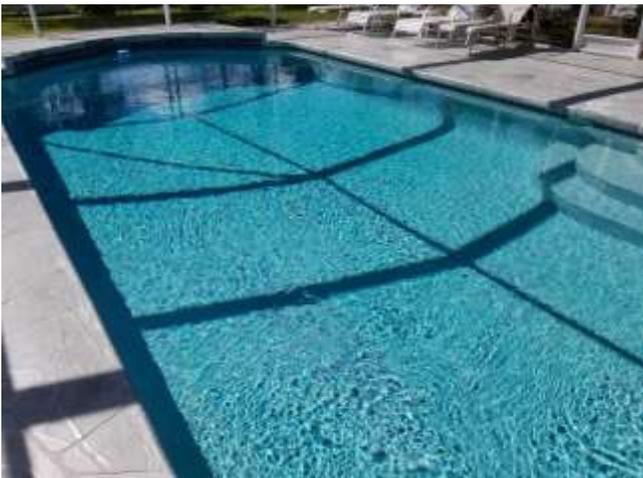
The pools finish was good, the light was lit and a water fall function was noted to work. The pool motor and filter appeared older and possibly original but no defect was noted.  
**The pools heater did not start.**

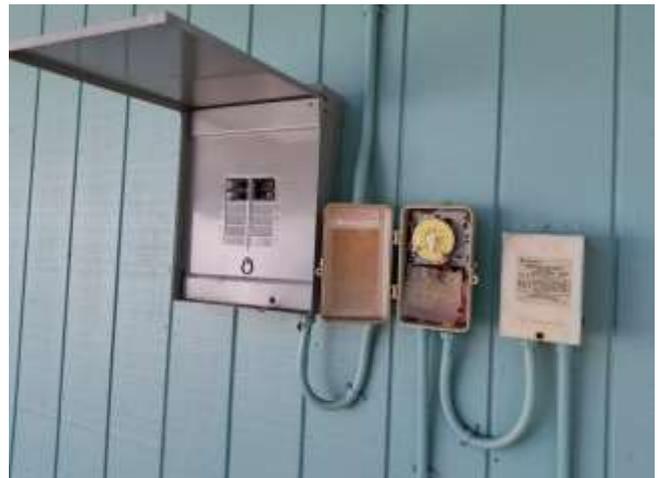
**The pool is not tested for leaks as a quality test requires a number of days to monitor the water level and getting into the pool to inject dye around all of the inputs, out-posts and lights do detect leaks.**

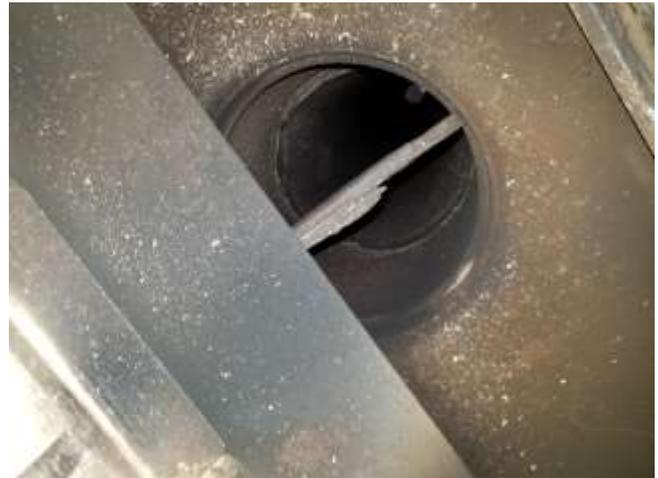
**The fireplace damper functioned.**

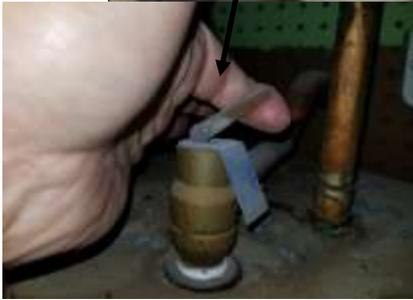
**\*The pressure relief valve on the water heater did not release when tested. It is not uncommon for valves which are more than a few years old to stick due to our mineral rich water.**

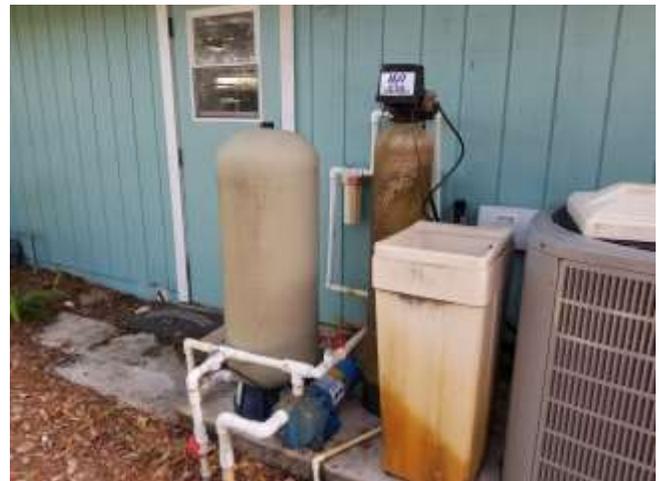
**The pump and pressure tank and functioned properly with a pressure range of 40lbs to 65lbs which is within the typical range. The water flow and pressure appeared stable and typical.**

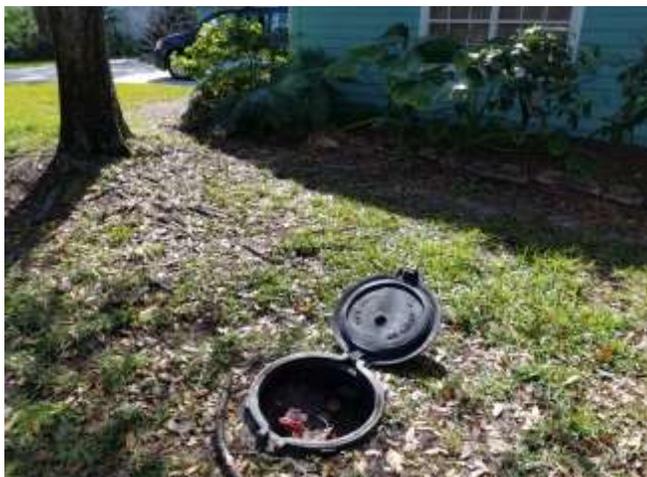
**A gas tank is noted in the front west lawn. Ownership of the tank is not determined. Gas systems are not inspected and if desired can be reviewed by the service provider.**

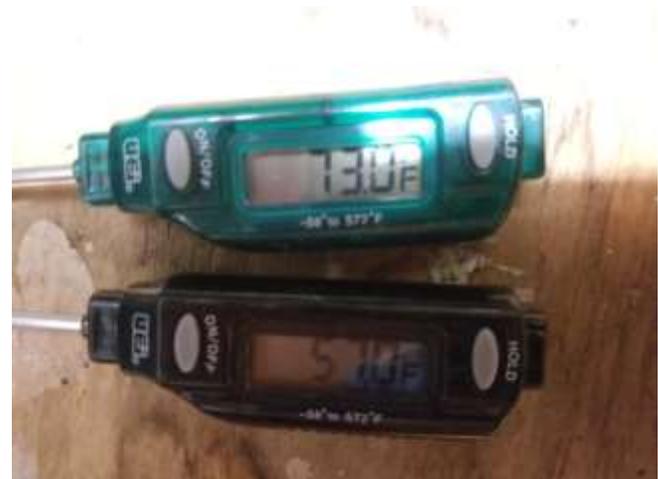
The temperature differential was 16 deg.

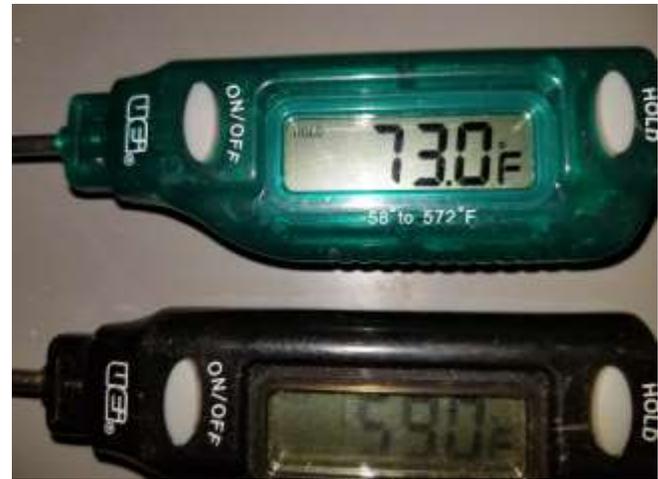
**The temperature differential was 14 deg.**

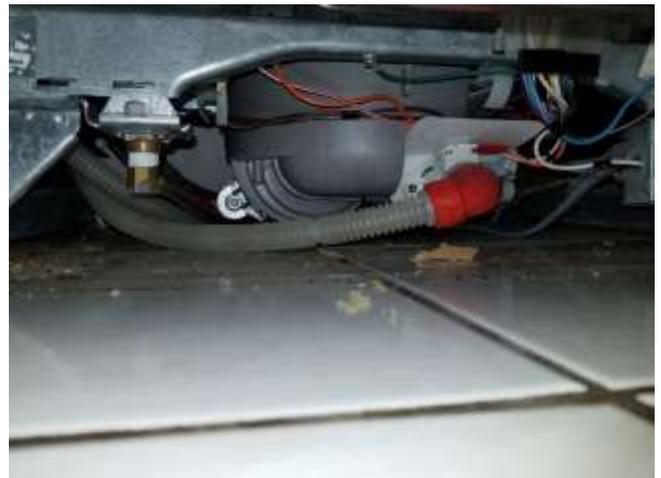
**View under dishwasher**

Exhaust fan	X				Vented through the roof to the outside.
Microwave	X				The unit was noted to heat water.
Dishwasher	X				The unit was secured and no water was observed underneath.

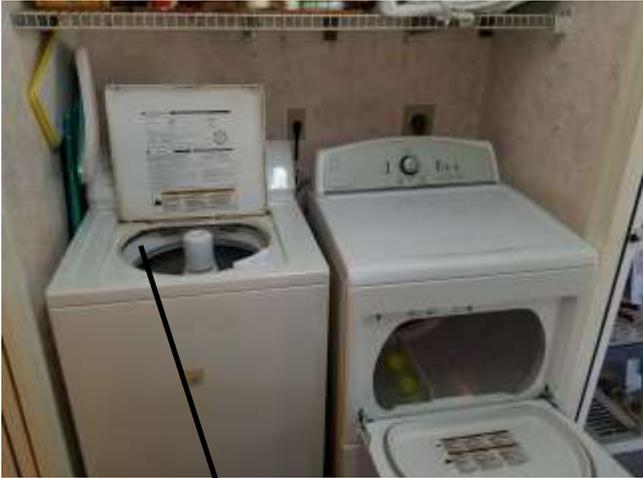
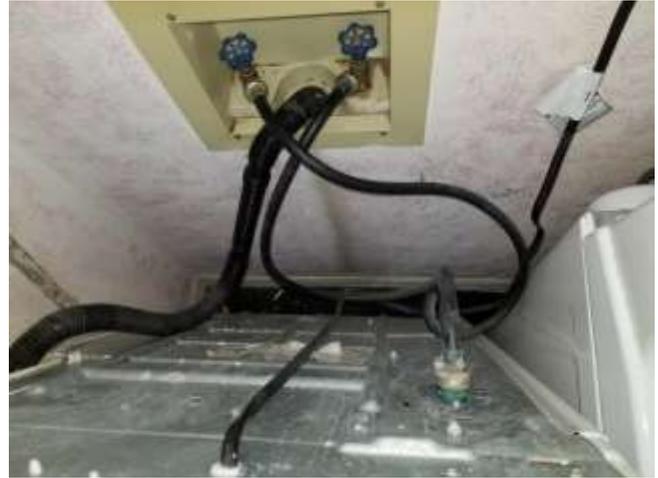
**Laundry equipment**

COMPONENT	S	A	N	I	OBSERVATIONS
Washing machine		X			Kenmore brand, manufactured (not known 10+yrs, with rubber hoses, It is suggested the fill hoses be upgraded to high pressure type fill hoses. Only the normal cycle is tested. <b>*On the cloths washer some rust and painting was noted on the lid and around the washer baskets rim.</b>
Dryer & venting	X				Kenmore brand, manufactured September 2012, electric, with foil exhaust hose, see attachment. The dryer vent line should be checked annually and cleaned if necessary.

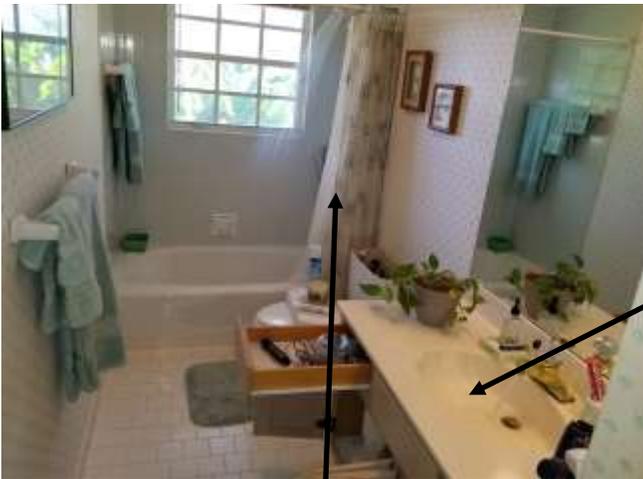
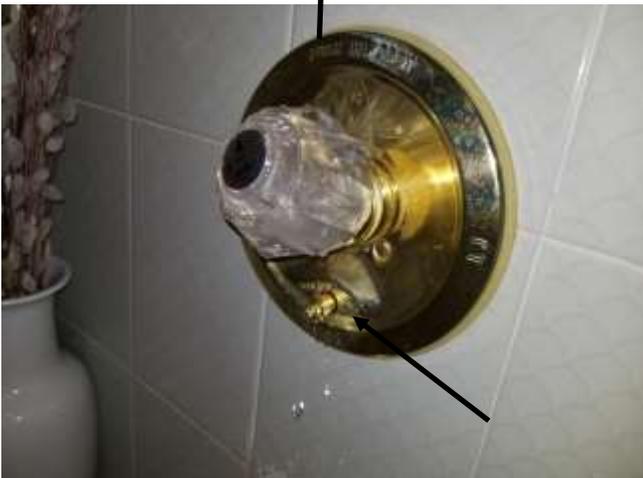
**In the east hall bath tub water drips from the faucet handle when on.**

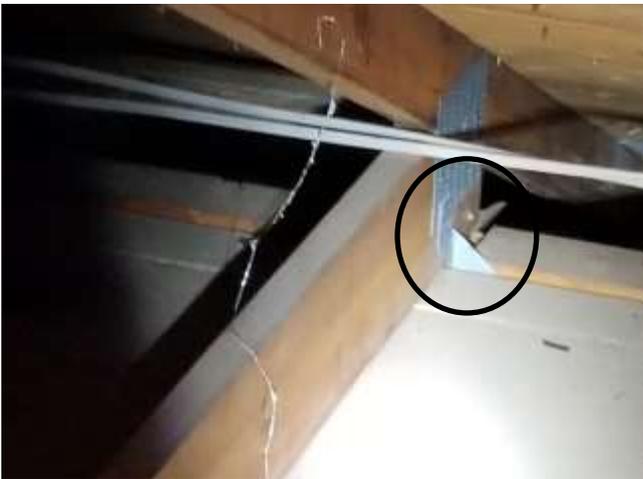
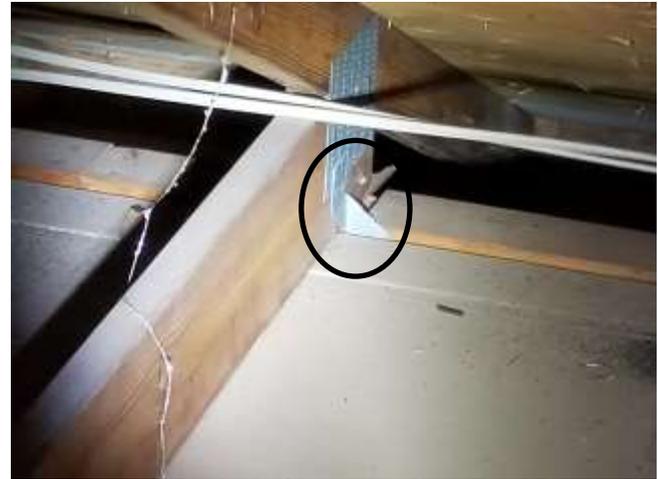
**Single wrapped metal straps wrapping the top of the truss used to secure the roof rafters to the CBS walls.**

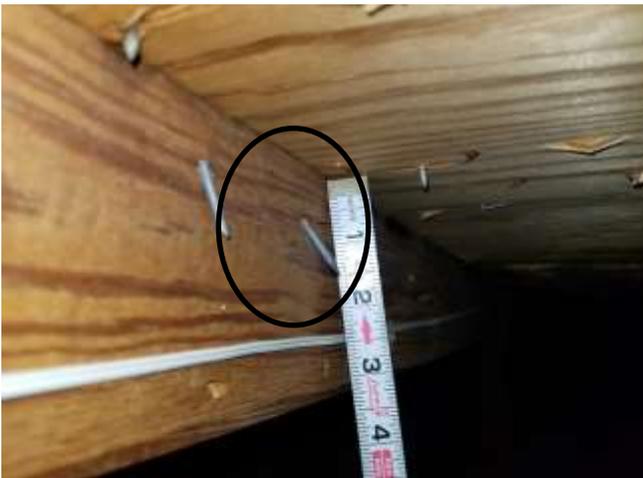
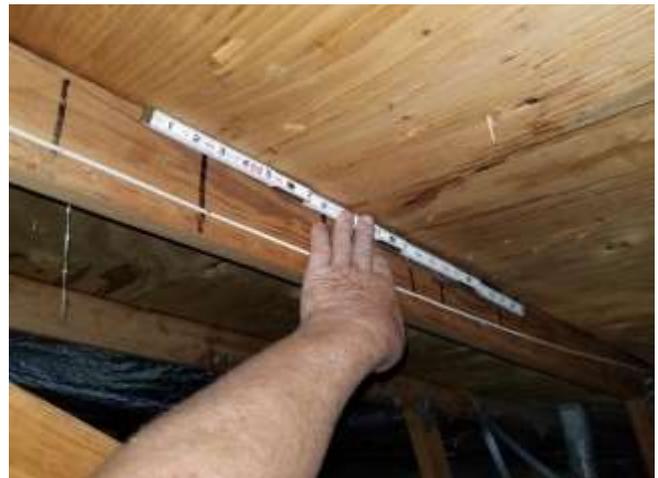
**Roof nailing pattern of 8pn nails installed 6" oc center in the field and 6"oc center on the edge is determined with the use of a Zircom MT6 metal detector.**

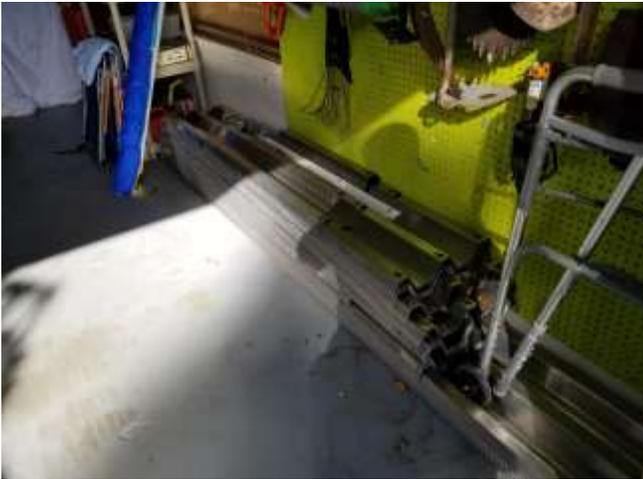
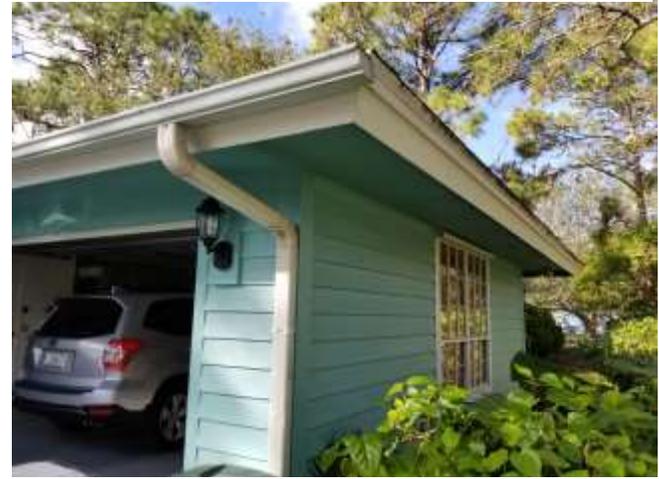
**Miami Dade hurricane rated corrugated shutters for all glazed openings (windpws and doors). 3 skylights are replaced and are Miami Dade hurricane rated. The garage door is hurricane rated. The front entry door is not a glazed openings but is not hurricane rated as is an older style wood door.**

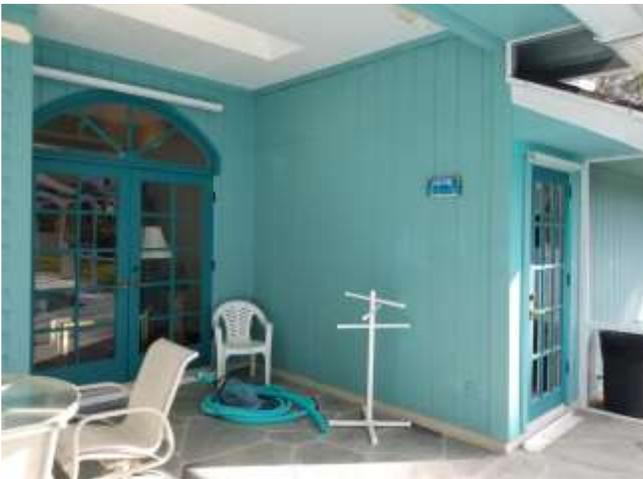
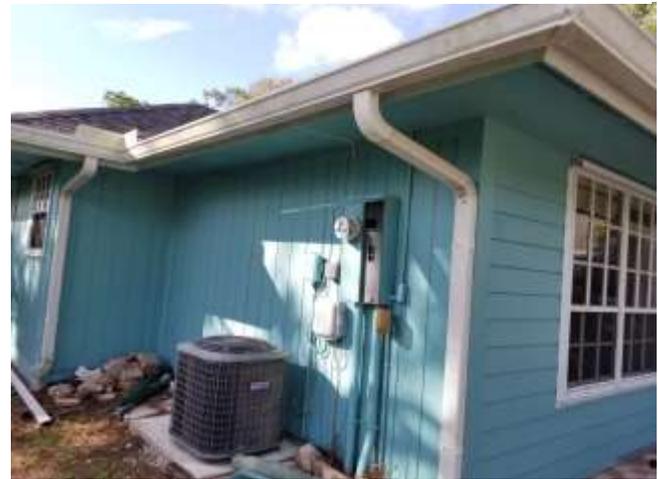
**Miami Dade hurricane rated corrugated shutters for all glazed openings (windows and doors). 3 skylights are replaced and are Miami Dade hurricane rated. The garage door is hurricane rated. The front entry door is not a glazed opening but is not hurricane rated as is an older style wood door.**

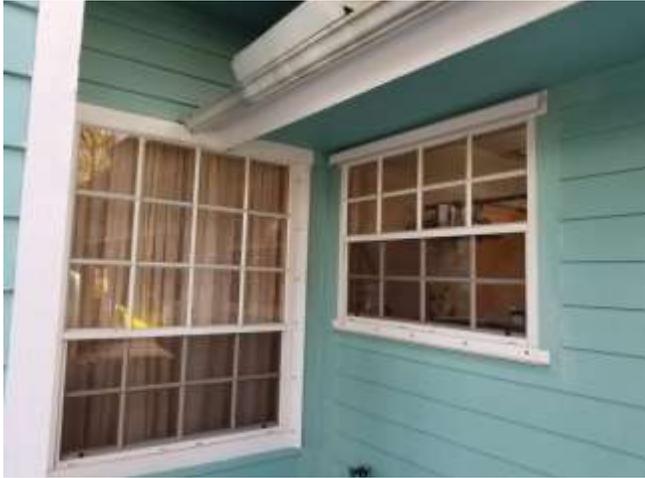
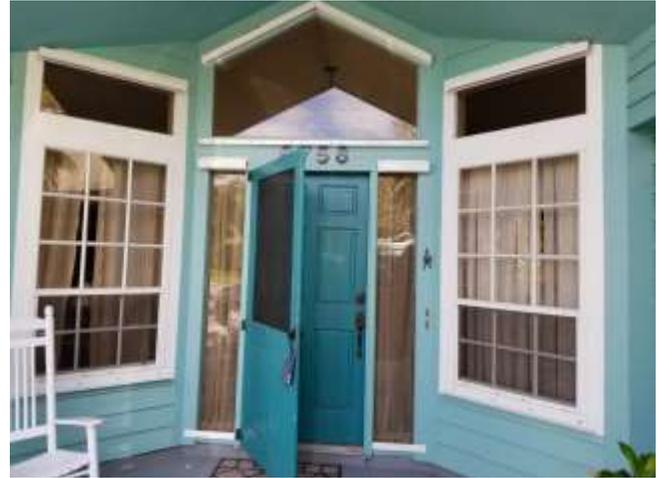
**Views of home and shutters protection**

**Miami Dade hurricane rated corrugated shutters for all glazed openings (windows and doors). 3 skylights are replaced and are Miami Dade hurricane rated. The garage door is hurricane rated. The front entry door is not a glazed opening but is not hurricane rated as is an older style wood door.**
